Bridgwater West Quay Emergency Works – Stabilisation 2012 Fleming Award awarded to Scheme

Stabilisation of the carriageway which was washing away with each tide. The carriageway contained High Voltage cables, live sewer and other services. Work was completed between tides with a fast setting high strength shotcrete. The stabilisation works then allowed Engineers to devise a suitable long-term solution to the collapsed river wall and its eventual reconstruction.

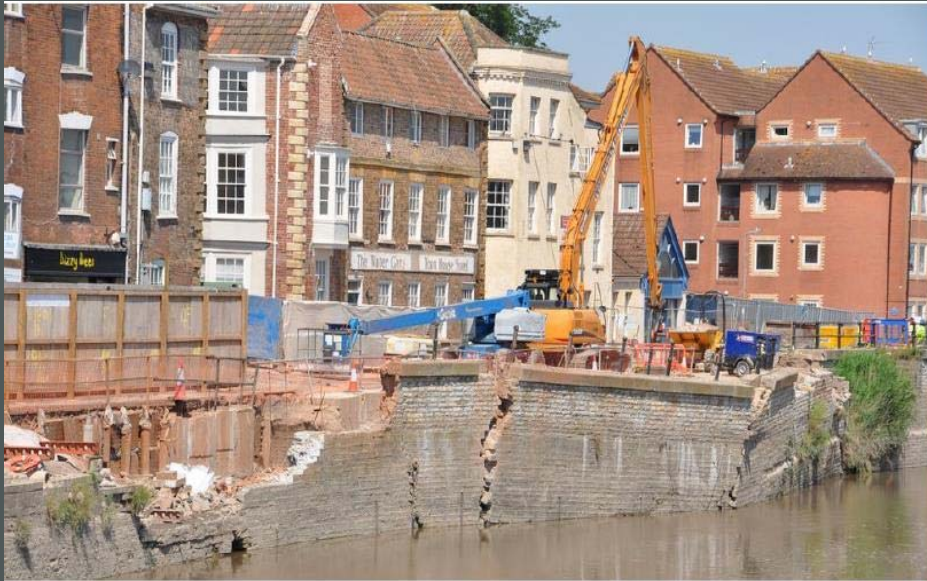
With this short-term stabilisation, the carriageway would have continued to erode, resulting in the damage of the town's services and potential collapse of the riverside buildings.

- Rapid response, the Shotcrete team and their specialist in-house equipment were on site within 12 hrs.
- Use of fast setting C40 shotcrete, reinforced with steel fibres, enabled works to be completed between tides.
- Use of suspended access reduced risk of operatives having to work in the collapsed area.
- Shotcrete stabilised the wall enough that it remained in place throughout the repair without it collapsing. This enabled the safe removal of the masonry and its subsequent reuse.
